May 25, 2012

**MEMORANDUM**

**SUBJECT:** Second quarterly cap inspection at the San Jacinto River  
Waste Pits superfund site

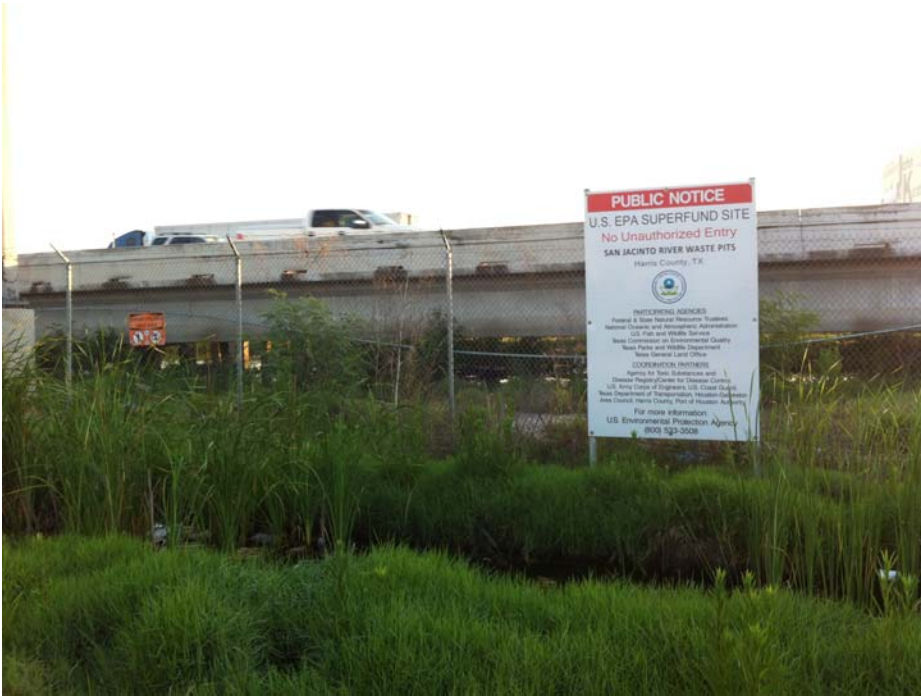
Photo 1- View of Site perimeter fencing and Site signage South along I-10, West of San Jacinto River

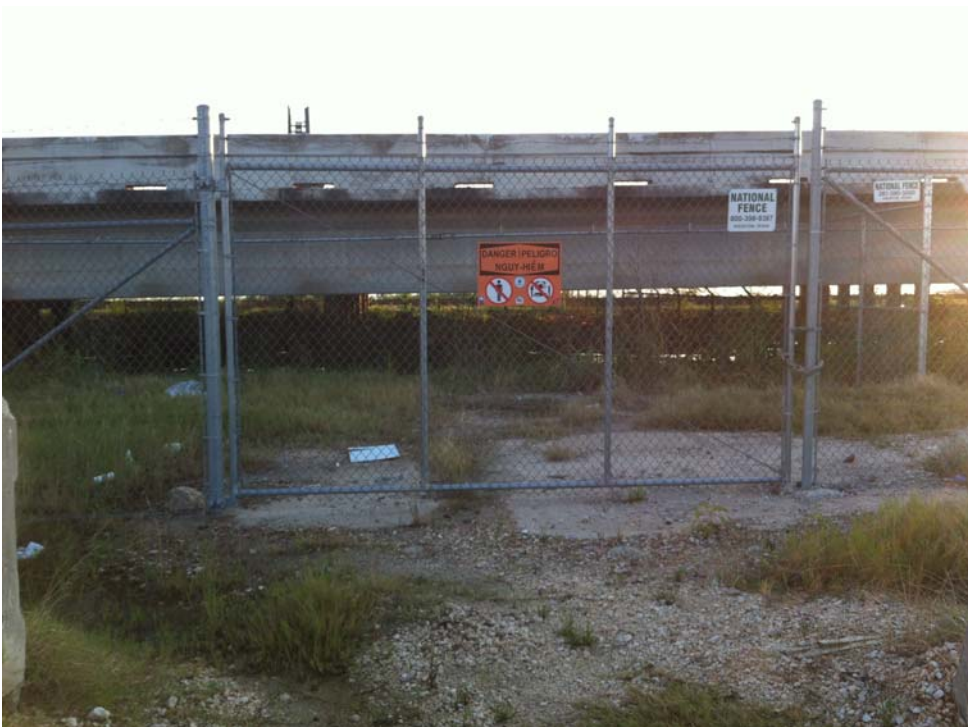
Photo 2- View of Site perimeter fencing South Gate along I-10, West of San Jacinto River

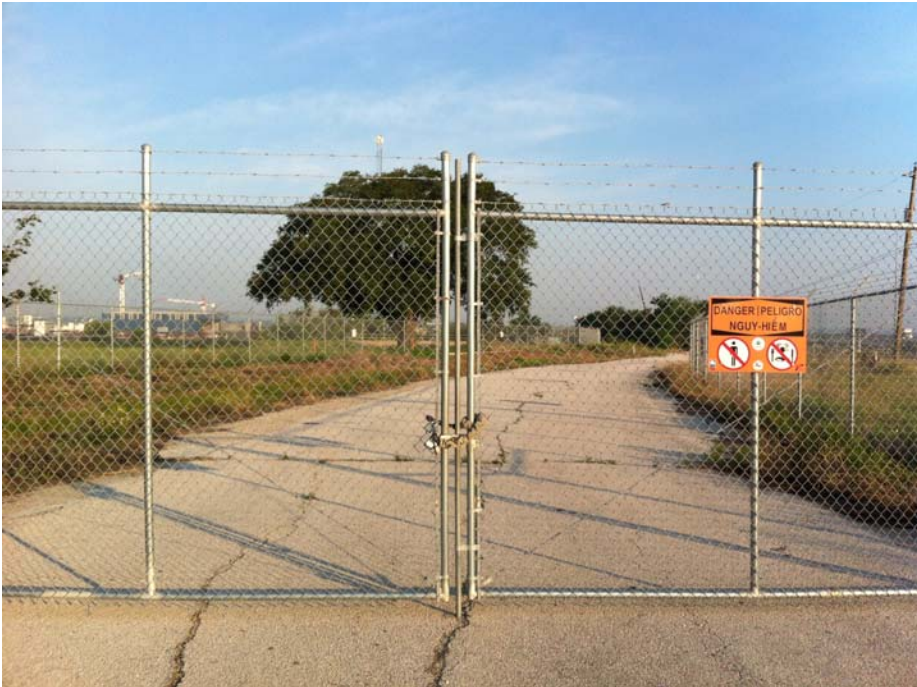
Photo 3- View of Site perimeter fencing East Gate, East of San Jacinto River

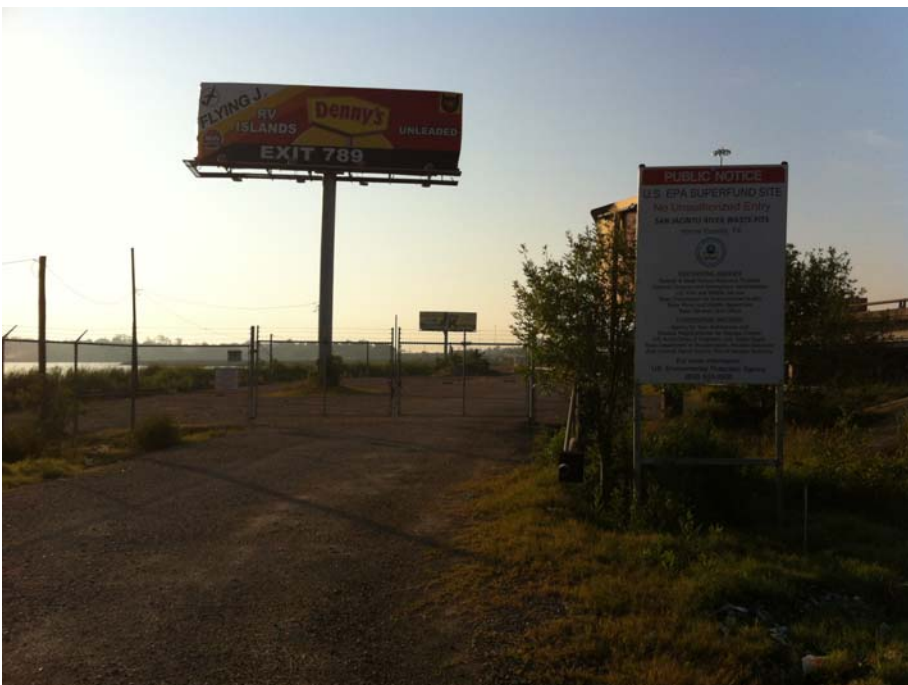
Photo 4- View of Site perimeter fencing Main Gate North along I-10, West of San Jacinto River

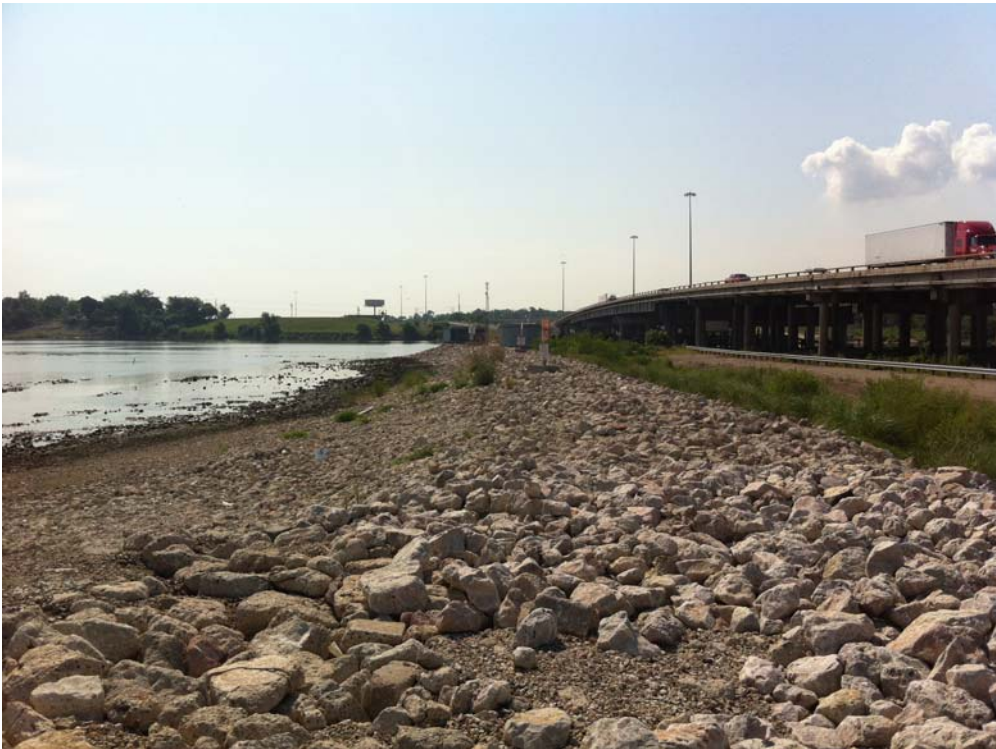
Photo 5- View of armor cap's southern berm and eastern impoundment North of I-10, West of San Jacinto River

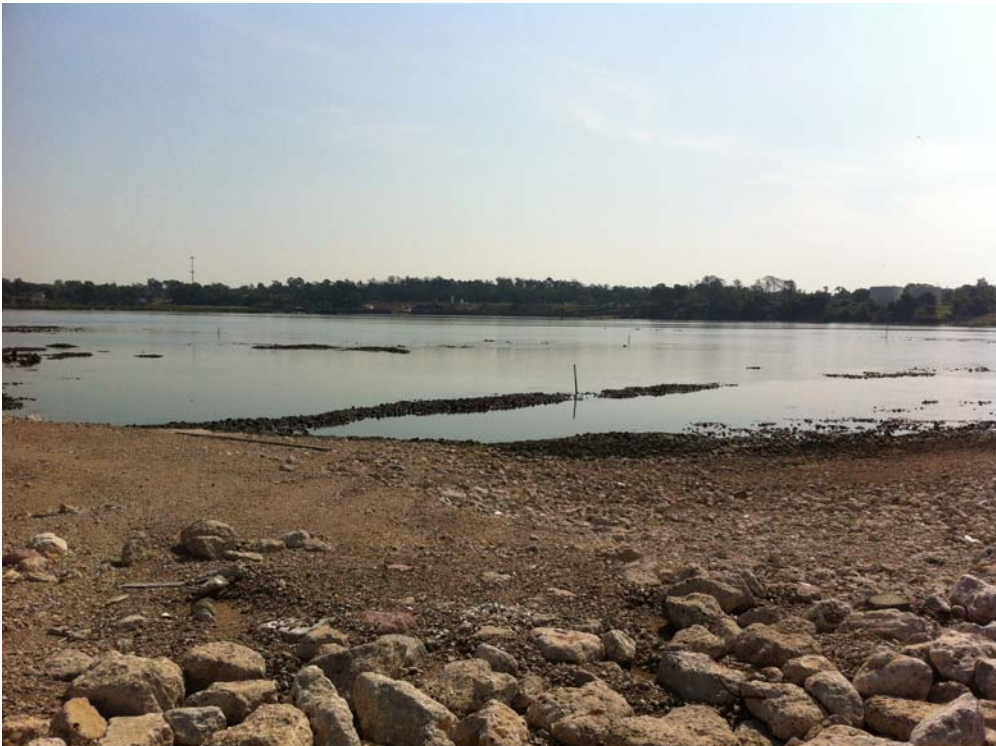
Photo 6- View of eastern impoundment of armor cap North of I-10

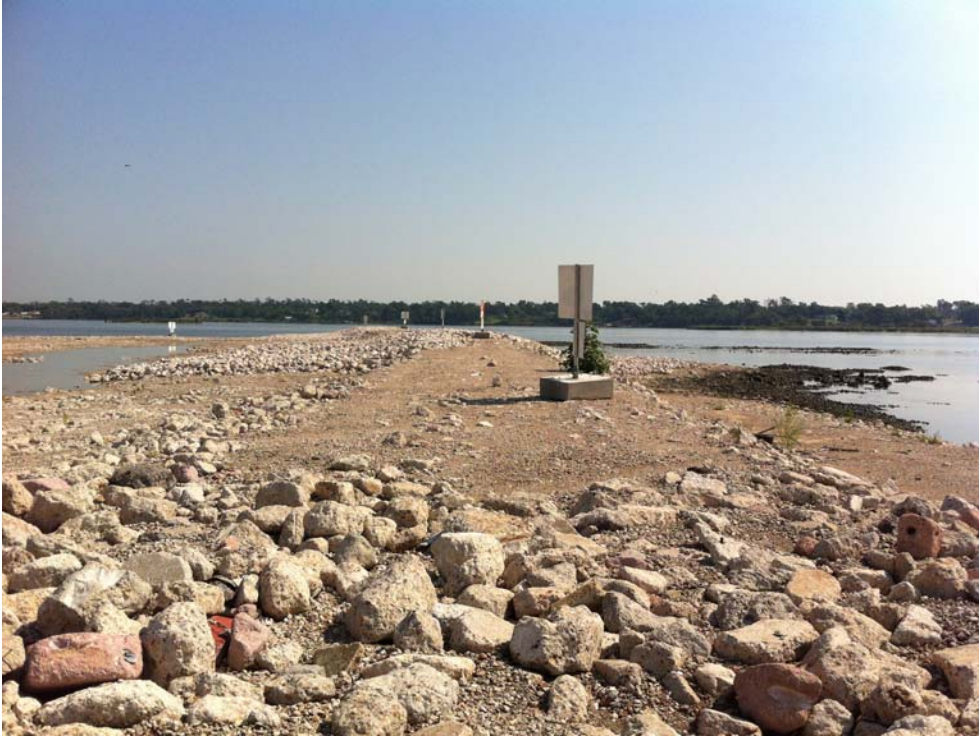
Photo 7- View of central berm with both western and eastern impoundments of armor cap North of I-10

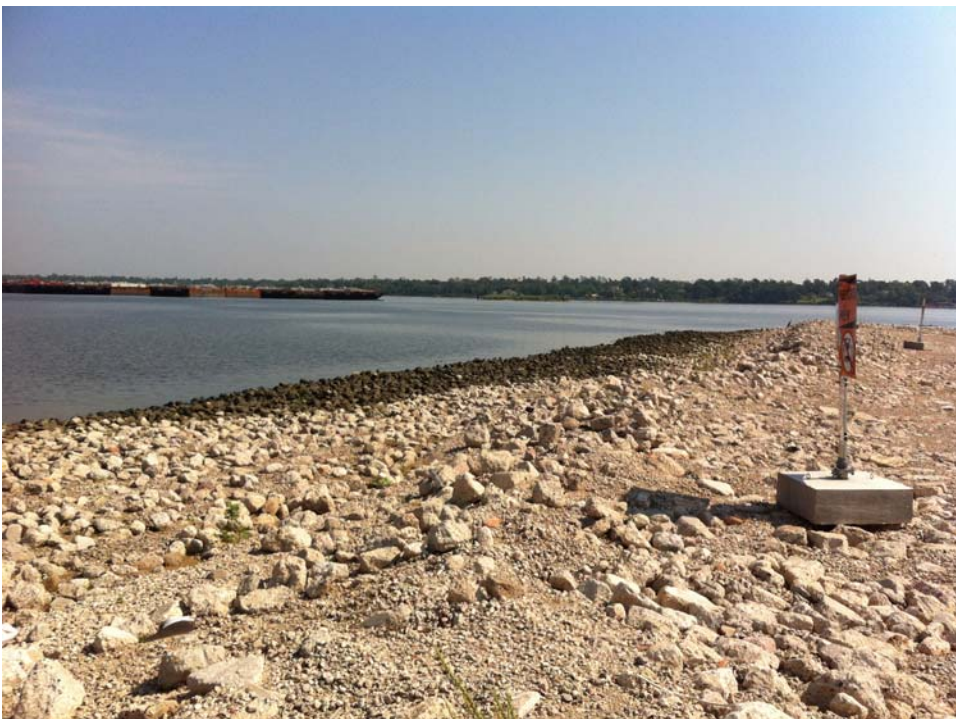
Photo 8- View of western berm and western impoundment of armor cap North of I-10

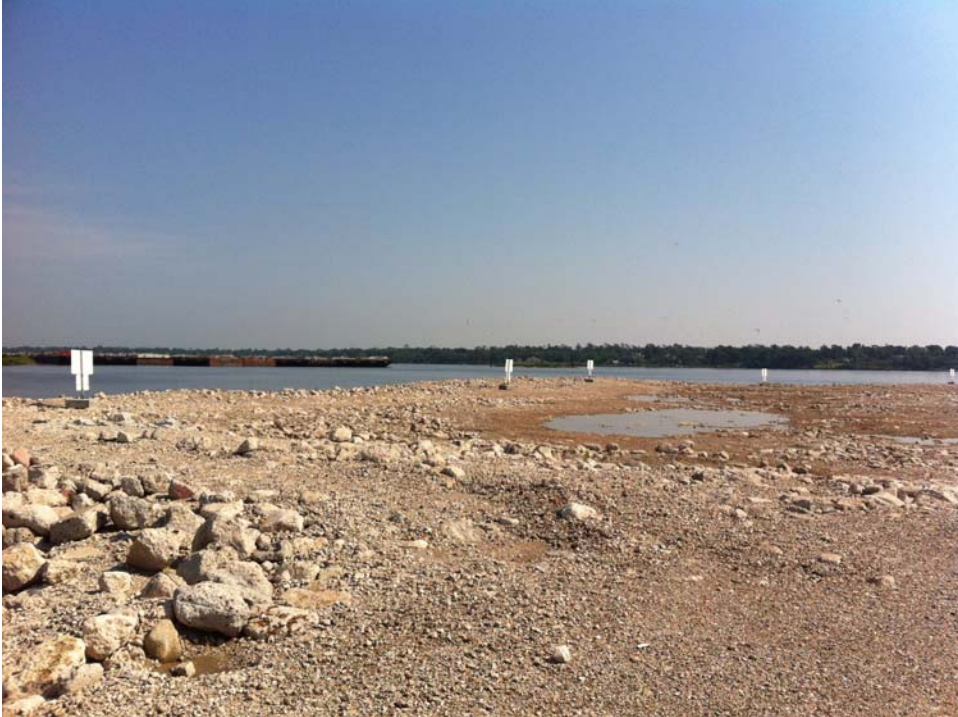
Photo 9- View of western berm and western impoundment of armor cap North of I-10
